# PUMPING OF HIGHWAY AND AIRFIELD PAVEMENTS

#### PUMPING OF HIGHWAY AND AIRFIELD PAVEMENTS

E. J. Yoder Research Engineer

Joint Highway Research Project Project C-36-45F File 6-18-6

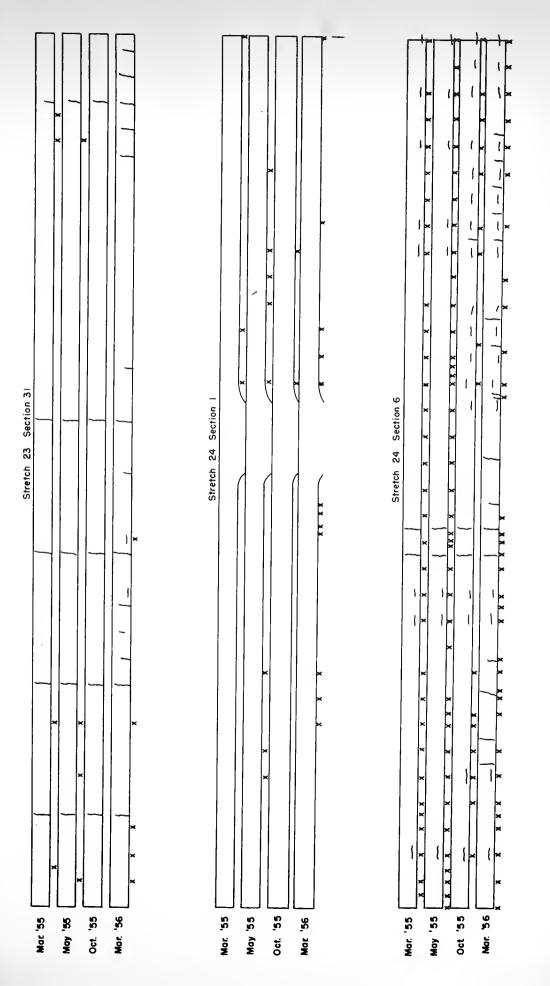
PROGRESSION OF BLOWING AND CRACKING
U.S. 52 NORTH OF LAFAYETTE
DENSE GRADED GRAVEL – THROUGH SHOULDER CONSTRUCTION
CONSTRUCTED SEPTEMBER 1952
FIG. 6

These data illustrate that pavement distress as evidenced by crack formation is preceded by blowing activity. Also where blowing is not evidenced soon after the pavement is constructed, little or no cracking develops at a later date.

Transverse cracks develop primarily during the cold season, while restraint cracks develop during summer months. It is important to note also that blowing was not encountered at road turn-outs and that little cracking exists at these locations.

A definite time lag exists between blowing and the formation of cracks (see Figure 9). Furthermore, blowing does not increase appreciably after the action has started. In fact, as previously mentioned, evidence is available which indicates that blowing activity decreases and in some cases completely stops after a period of several years (Table 2)

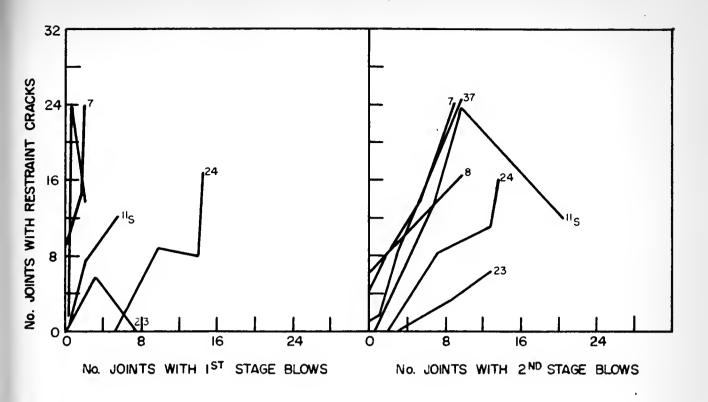
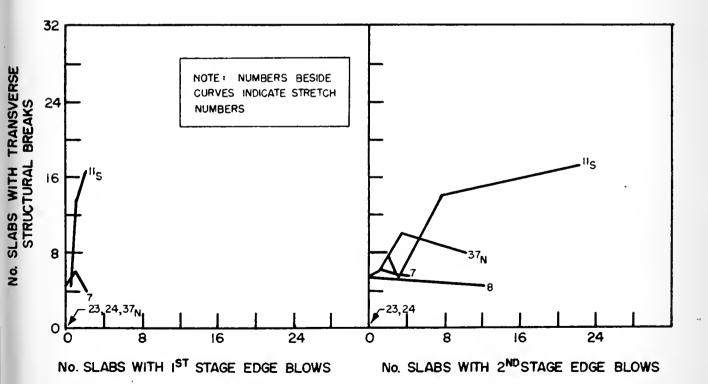
FIG. 10 VARIATION OF STRUCTURAL DEFECTS WITH BLOWING (GRAVEL, TRENCH CONSTRUCTION, TRAFFIC LANES)

measured by number of cracks in the concrete pavement. The upper curves show data for restraint cracks while the lower are for transverse cracks occurring in the end 1/3 of the slabs. These data indicate that cracking is not necessarily associated with first stage blows, and that more cracks occur when blowing has progressed to the second stage. The numbers beside the curves represent the survey stretch numbers. Therefore each line represents data for a particular highway, but for different sections on that highway. It is significant that the sections of a given highway showing greatest distress on the basis of crack formation also show greatest second stage blowing activity.

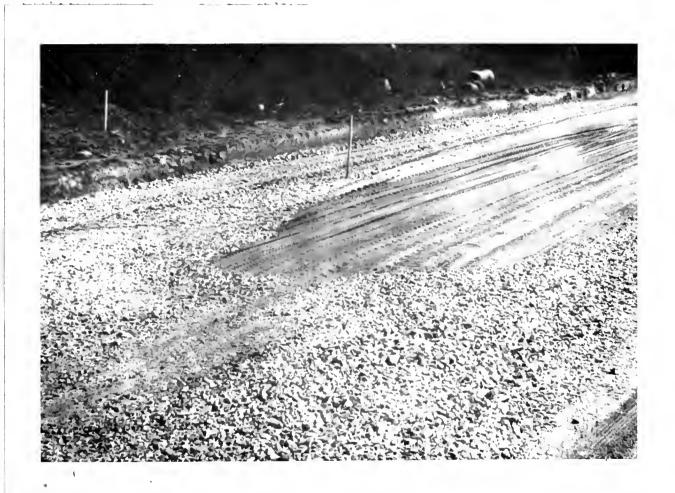
Figure 17 Leveling Course on Open Graded Base

There are several possible reasons for a layer of this type to occur under a slab: (1) it may have been placed on top of the base as a leveling course (see Figure 17); (2) it may result from rolling the aggregate base during construction: (3) it may result from the finishing operation on the base; or (4) it may represent an accumulation of fines due to pumping action. Regardless of the source of this material, its effect on blowing is at once apparent. Figure 11 reveals that this material as encountered in this study is primarily sand containing an average of 17 percent by weight passing the No. 200 mesh sieve at joints showing no blowing. Figure 16 reveals that on the newer pavements (those constructed after 1950) the upper 1/2-inch of the bases contained an average of 27 percent fines at joints showing second stage activity. However, when considering the older pavements it is seen that this layer contains an average of 21 percent suggesting that the material pumped out from under the pavement comes from this layer. If the above is a correct hypothesis, it follows that the material which enters the joint and causes restraint cracks comes from this layer.

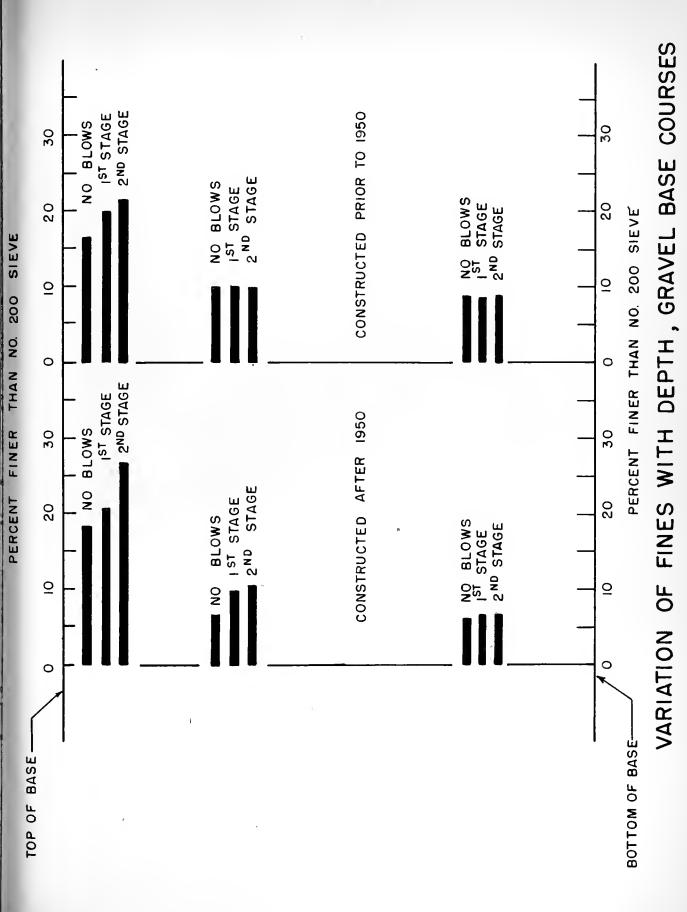
FIG. 16

Data obtained from this study have indicated that second stage blowing activity is associated primarily with gravel base courses and that the source of the sandy material found at pavement edges in the vicinity of second stage blow holes is the extreme upper layer of the base.

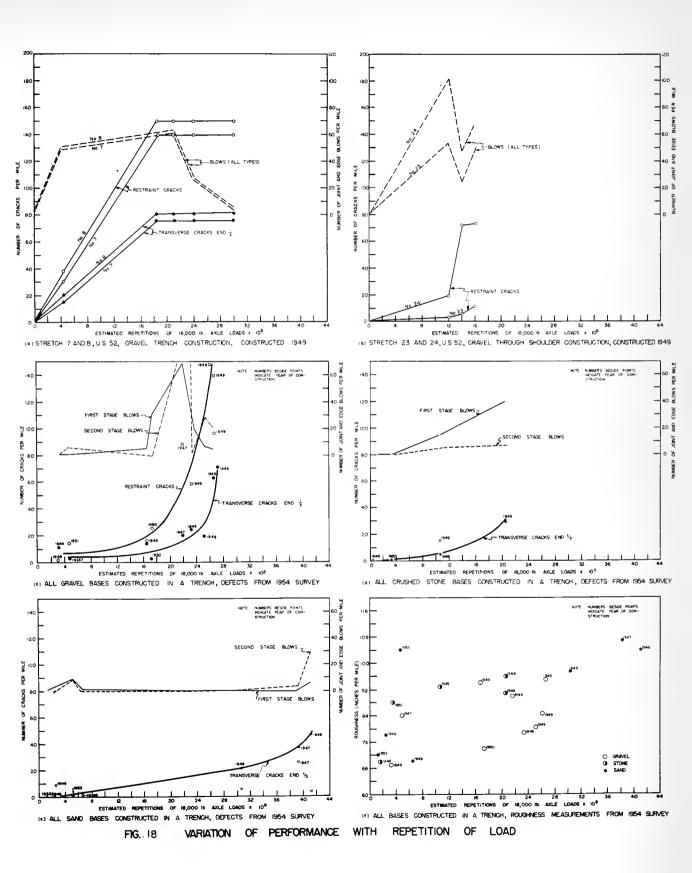
Figure 18 shows a summary of the performance data on the basis of traffic. For these curves an estimate was made of the total number of repetitions of 18,000 pound axle loads from the date of construction up to the time of the survey. These data were calculated using equivalent wheel load procedures.

Data in Figure 18 show that the occurrence of restraint and transverse

Continuous surveys have been made on US 52 north of Lafayette, Indiana. The curves in 18(a) show data for a section of road constructed in 1949, while those in 18(b) show data for a section built in 1952. The former road was constructed using trenching procedures while the latter was constructed with the base extending through the shoulder. It is apparent from these data that the stretches of roads showing greatest blowing activity have also shown the greatest number of structural defects. Also, blowing activity has been decreasing on stretches 7 and 8.

The effect of repetition of load is apparent from curves shown in figures 18 (e, d, and e). Pavements built using identical designs and constructed during the same year have shown distress proportional to number of heavy axle loads using the road. A discrepancy can be noticed when comparing figures 18(a) and 18(c). No additional cracking has been found on stretches 7 and 8 after about three years of traffic, although the curves in 18(c) indicate that cracking continues for an indefinite period. Therefore it must be reasoned that the shape of the curve as in

18(c) should be much steeper for lower traffic values than is shown on the graph. Nevertheless, the correlation of defects with number of load repetition is unmistakable.

Figure 18(f) shows roughness data for pavements built on all types of bases. Sand and stone bases have resulted in slightly greater roughness values, for comparable traffic, than gravel.

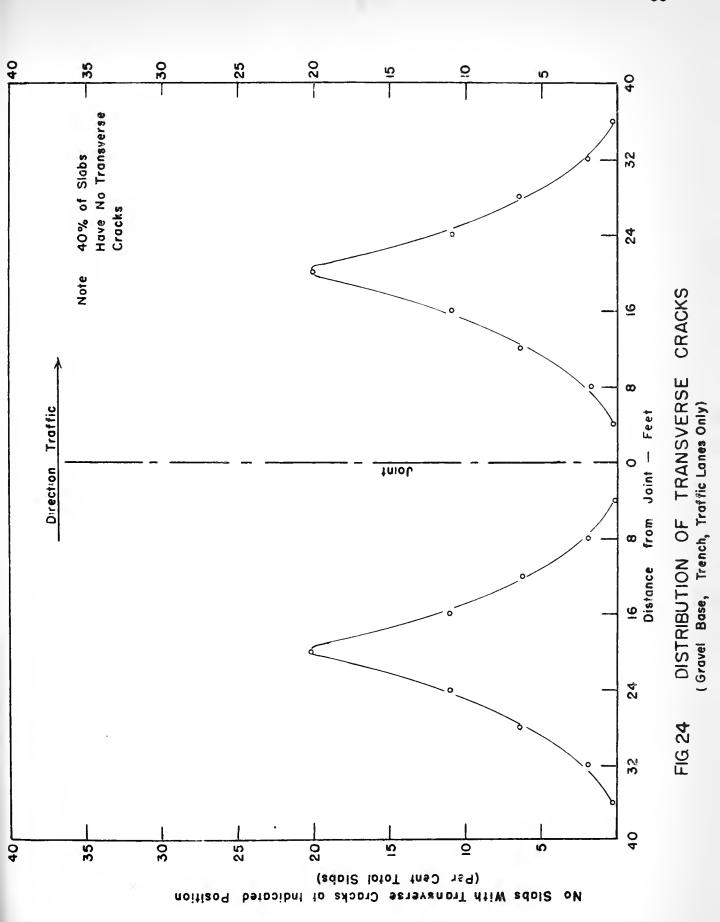
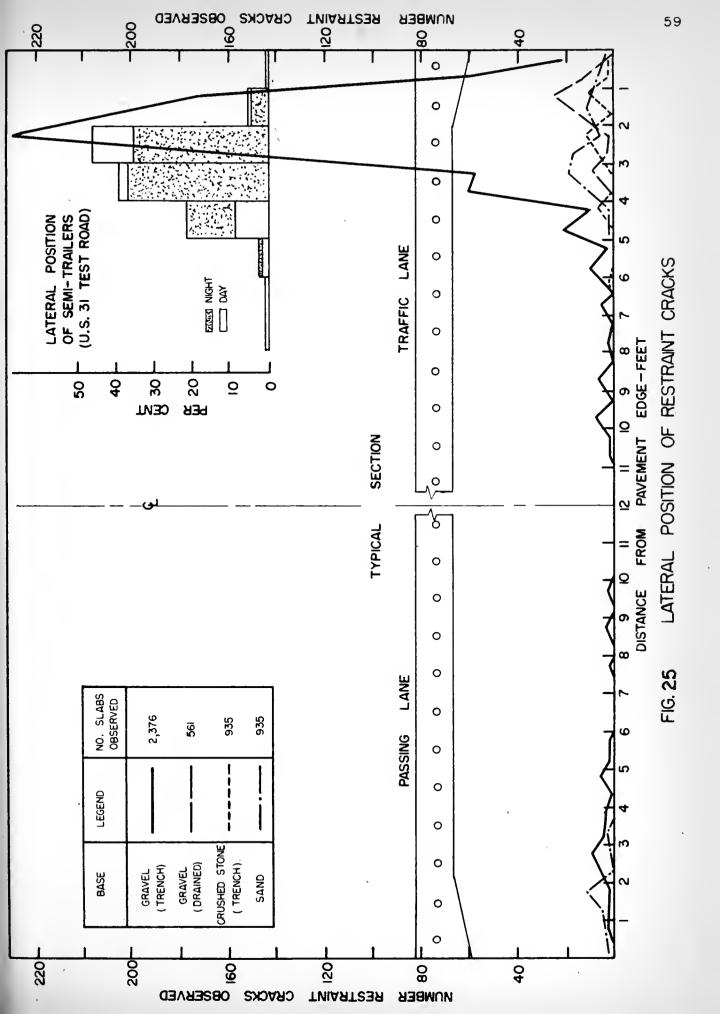
Figures 23 and 24 show distribution and length of restraint cracks and the lengitudinal distribution of transverse cracks. Transverse cracks are largely located in the centers of the slabs while the longest restraint cracks occur when the distance to the nearest transverse crack is less than eight feet.

It is believed that occurrence of restraint cracks is influenced by the pavement cross section. In Figure 25 it can be seen that by far the most restraint cracks occur at the transition from the thickened edge.

Also, most trucks travel inside the thickened edge. These facts indicate that use of the thickened edge is not warranted as used on these pavements.

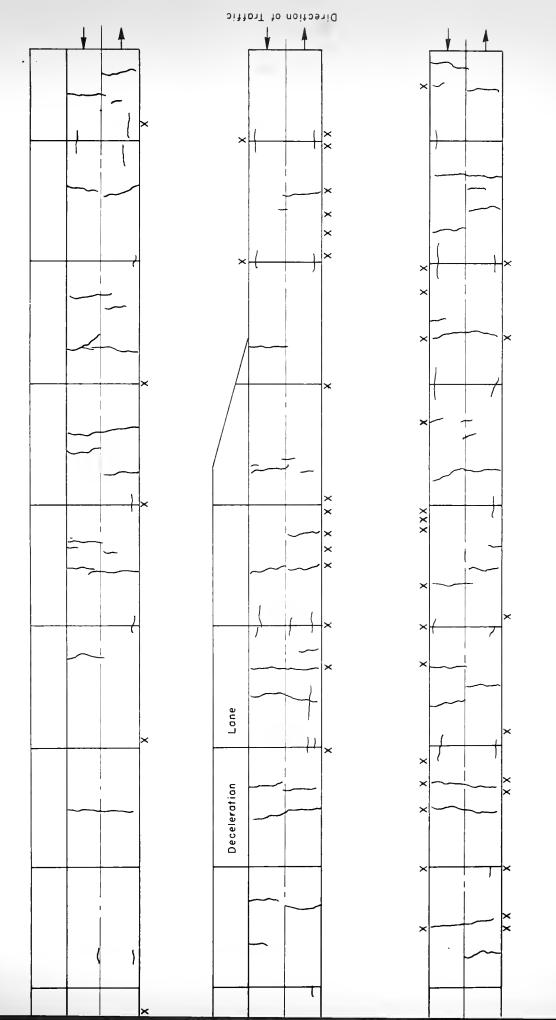
TABLE 6

Blowing and pavement cracking are most severe at the free edge of two pavement. This is shown by Table 6 which is a summary of data obtained on heavily traveled highways. It is significant that of the 135 road intersections and deceleration lanes observed, none showed any blowing and only about ten percent showed evidence of structural failure. Some cracking is apparent, but generally to a lesser degree than on pavements with turf shoulders.
